**PM8315  
TEMUX**

**DATA SHEET ERRATA**

**March, 2001**

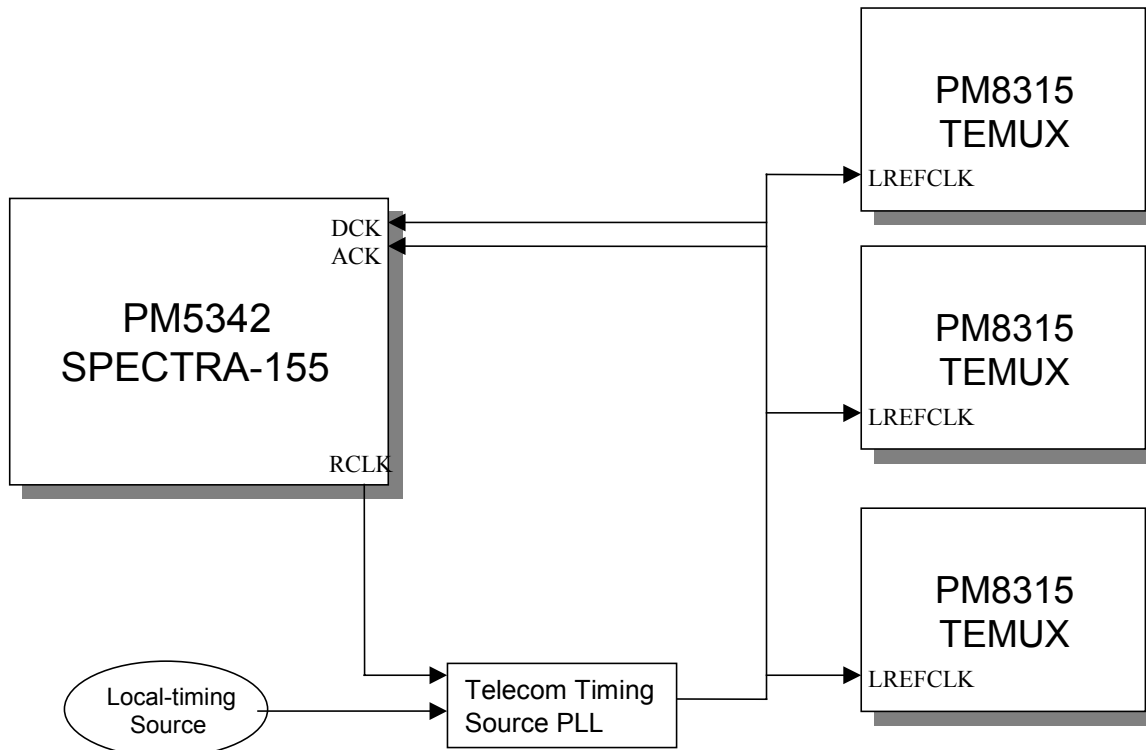
**Figure 1 Recommended System and Board Clocking**

Due to an issue in the TEMUX demapper there is potential for a loss of data bits, and resulting loss of frame on one or more T1 or E1 links. The effects of this issue are only manifested in the specific case when the demapper receives VT level pointer movements in combination with high-density bit stuffing. This issue will only effect VT/TU mapping mode and does not apply to any DS3 applications. Revision G of the TEMUX has been modified so that demapper errors in VT/TU mapping applications will not be possible.

The TEMUX demapper issue is aggravated by high density bit stuffing. High density bit stuffing can appear when the TEMUX mapper is mapping a synchronous tributary, where the transmit T1/E1 clock (SREFCLK, CTCLK, CECLK or CMV8MCLK) is frequency locked to the transmit telecom bus clock (LREFCLK). This issue may also be manifested when the mapped T1/E1 clock has a minute PPM offset relative to the SONET/SDH virtual container **and** there are VT level pointer movements. The error condition is such that the lower the frequency of pointer movements the smaller the permissible PPM offset of the T1/E1 clocks

for error-free operation. VT level pointer movements are required for this error case; if pointer movements are minimized with the configuration as shown in Figure 1, the potential for errors will be greatly reduced.

There is no possibility of errors due to this demapper issue if pointer movements are eliminated. Figure 1 shows the recommended system and board clock configuration to minimize pointer movements. This configuration will not eliminate the potential for VT-level pointer movements already in the receive stream.

The required clocking configuration must have both the telecombuss looptimed as well as the SPECTRA. To looptime the telecombuss the LREFCLK input of the TEMUX must be sourced from the RCLK output of the SPECTRA-155. RCLK also needs to be connected to DCK(D15) and ACK(C12) of the SPECTRA so the entire Telecombuss remains synchronous. To looptime the SPECTRA to prevent the generation of outgoing pointer movements, the LTE bit of register 00H must be set. An alternative to looptiming SPECTRA is to input the network clock into TRCLK on the SPECTRA and the Telecom Timing Source PLL.

Note: RCLK is pin L17 of the SPECTRA and is enabled by setting the RCLKEN bit in register 80H. LREFCLK is pin W12 of the TEMUX.

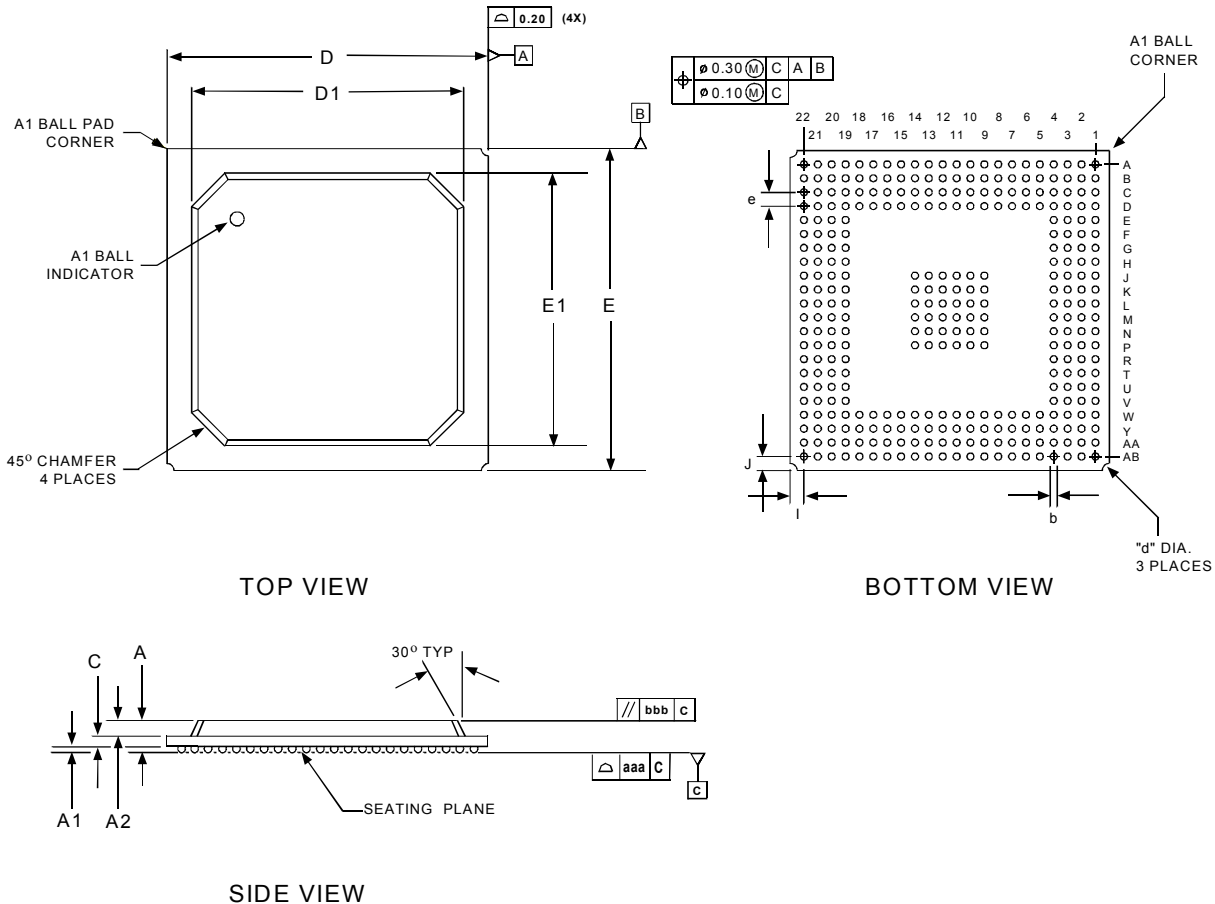
**5.8. TEMUX Mechanical Drawing**

The height dimensions listed in the Mechanical Information section of the datasheet are incorrect. The dimension in error is the thickness of the package. The following figure contains the correct dimensions.
