S/UNI-JET DATASHEET ERRATA

PM7347 S/UNI-JET

SATURN USER NETWORK INTERFACE (JET)

ISSUE1 MARCH 2000

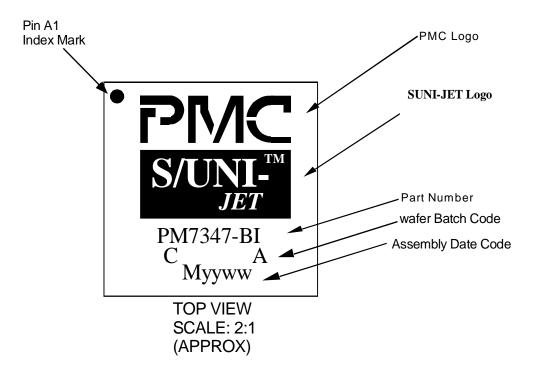
Figure 1: PM7347 S/UNI-JET Branding Format

The information contains in this document applies to the PM7347 S/UNI-JET revision A. The device revision code is marked at the end of the Wafer Batch Code on the face of the device (as shown in Figure 1). PM7347 S/UNI-JET revision A is packaged in a 256 pin Super BGA package.
