# MICROCHIP PIC18F2420/2520/4420/4520

## PIC18F2420/2520/4420/4520 Rev. A1 Silicon Errata Sheet

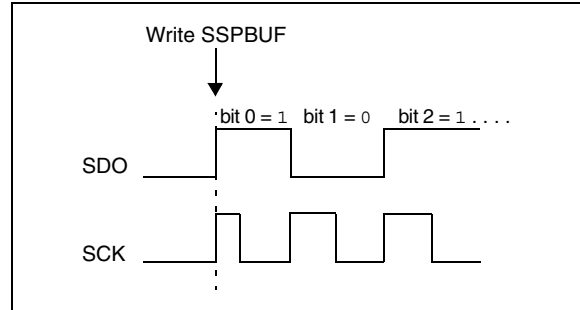
**FIGURE 1: SCK PULSE VARIATION USING TIMER2/2**

When the SPI is using Timer2/2 as the clock source, a shorter than expected SCK pulse may occur on the first bit of the transmitted/received data (Figure 1).

To avoid producing the short pulse, turn off Timer2 and clear the TMR2 register, load the SSPBUF with the data to transmit and then turn Timer2 back on. Refer to Example 4 for sample code.
